Tieton Dam Spillway Rehabilitation

by Larry Totten

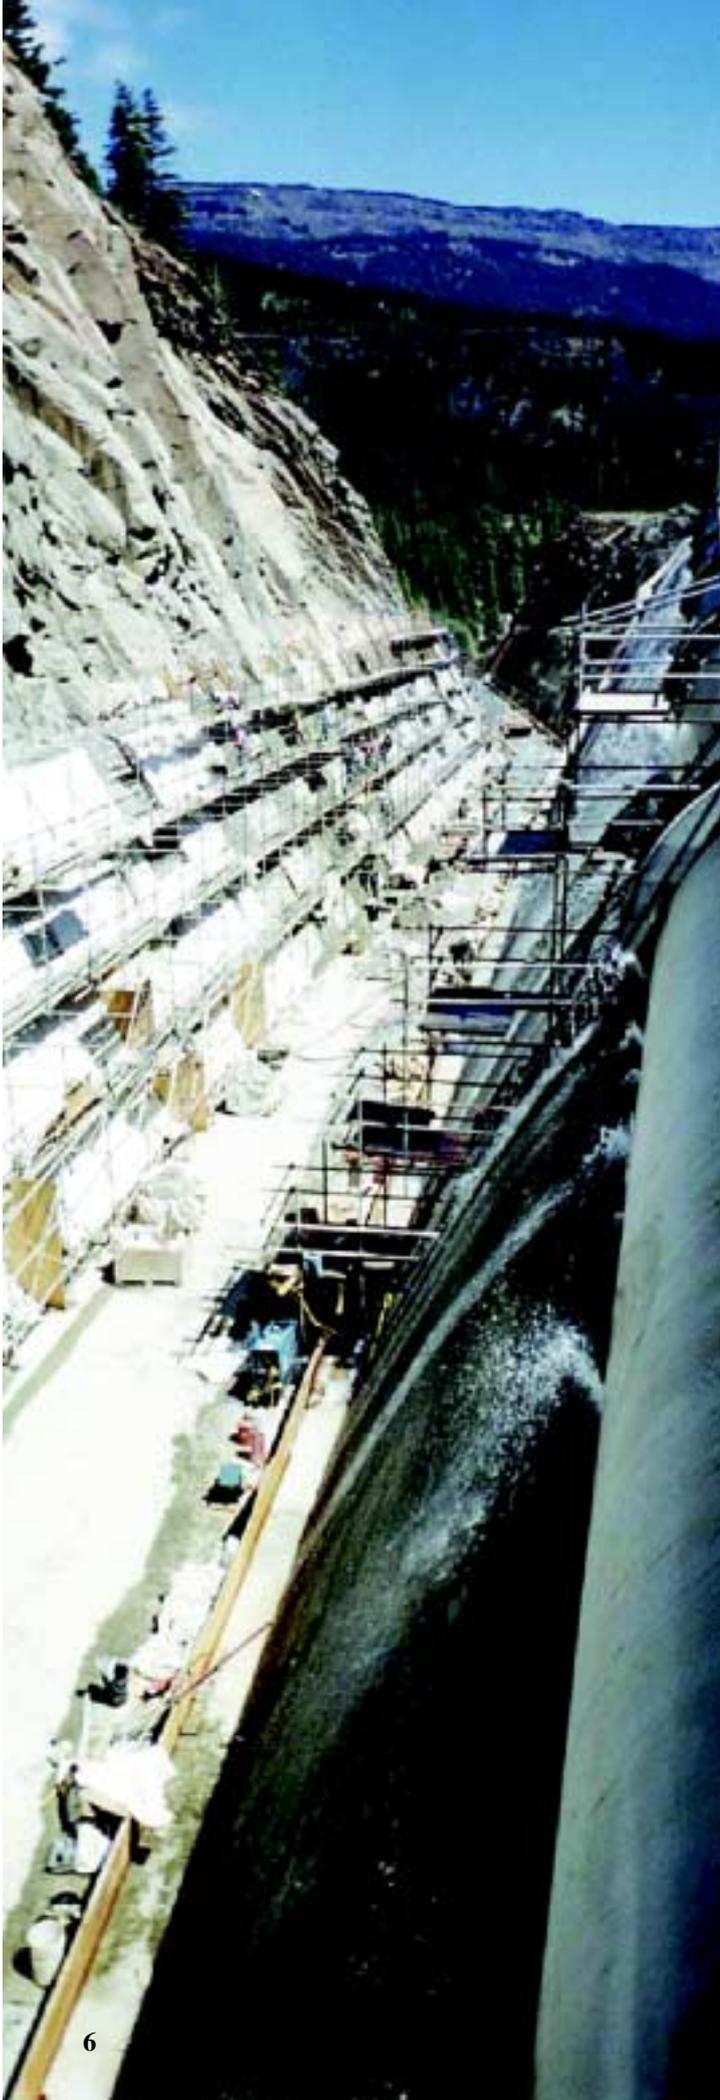
Figure 1: Partially completed spillway overlay showing scaffold system, alternate panel construction, and wet curing.
