2012 Outstanding Infrastructure Project

California Memorial Stadium

By Nur Kasdi and Larry Totten

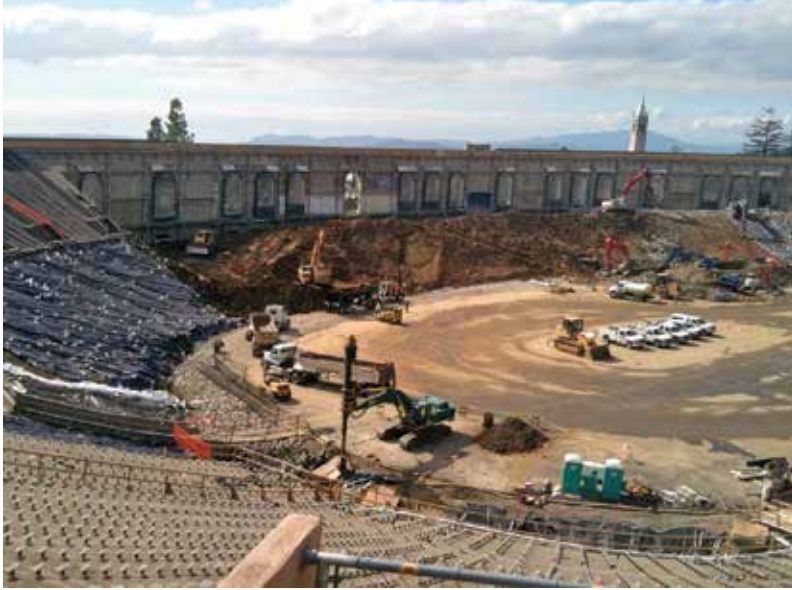
Fig. 1: Overview of the existing historic walls during demolition and excavation. A layer of shotcrete was later applied over the existing walls in various thicknesses from 5 to 36 in. (127 to 914 mm)

- Type 1: A historic wall shotcrete overlay intersected with a shear wall, with three curtains of No. 10 (No. 32M) and No. 9 (No. 29M) reinforcing steel with additional boundary reinforcing bar elements each 24 in. (610 mm) thick. Refer to Fig. 1 through 3.
- Type 2: A historic wall shotcrete overlay intersected with a shear wall with an existing pilaster obstruction and three curtains of No. 10 (No. 32M) and No. 9 (No. 29M) reinforcing steel with additional boundary reinforcing bar elements each 18 in. (457 mm) thick.
- Type 3: A historic wall shotcrete overlay with an embedded existing pilaster with reinforcing steel cages 20 in. (508 mm) thick.
- Type 4: A miscellaneous interior wall with an embedded column 12 in. (305 mm) thick.

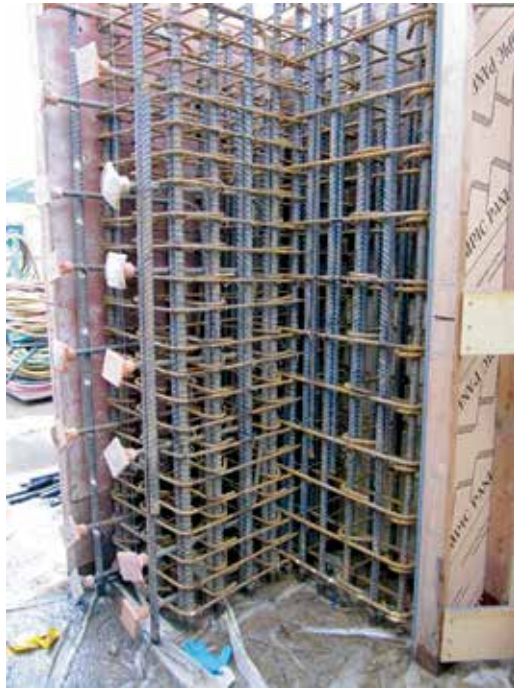
Fig. 2: Type 1 preconstruction test panel was composed of three curtains of No. 10 (No. 32M) and No. 9 (No. 29M) reinforcing steel with additional boundary reinforcing bar elements

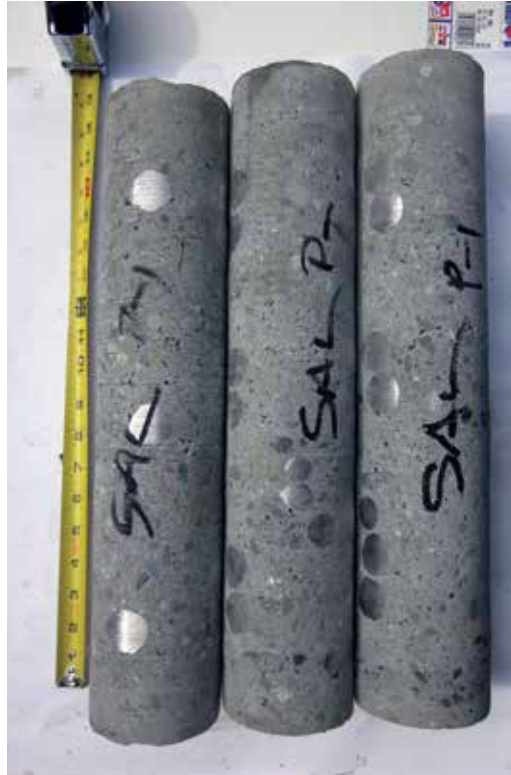
Fig. 3: Cores retrieved from Type 1 preconstruction test panel

Each nozzleman had to shoot a set of four preconstruction test panels that demonstrated the most challenging reinforcing steel configurations in the project. A mean grade of 2.0 was required to pass, with no single core having a core grade exceeding 3.0. Seven of the eight nozzlemen successfully passed the test. The engineer selected the following test panel conditions:

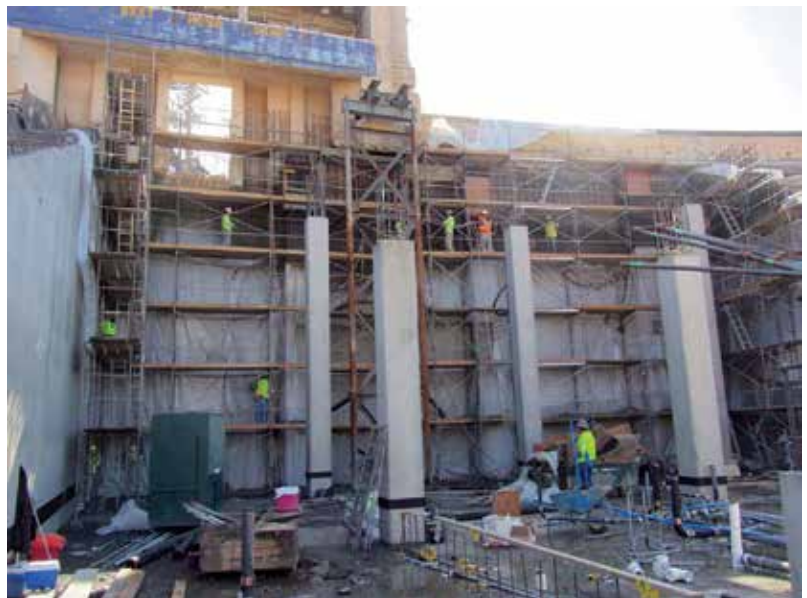
Fig. 4: Existing historic wall prior to shotcrete overlay application

The dense steel configuration motivated the JWG crew to take an unconventional approach to shotcrete application. At some locations, the actual field measurements for the historic wall overlays were over 36 in. (914 mm) thick and required full height installation of up to 40 ft (12.2 m; refer to Fig. 4 through 6). To address this problem, shotcrete was applied in 12 ft (305 mm) tall lifts. Once the concrete material set up, the next shotcrete lift was installed. Consequently, there were no major voids as a result of poor consolidation reported on the project.

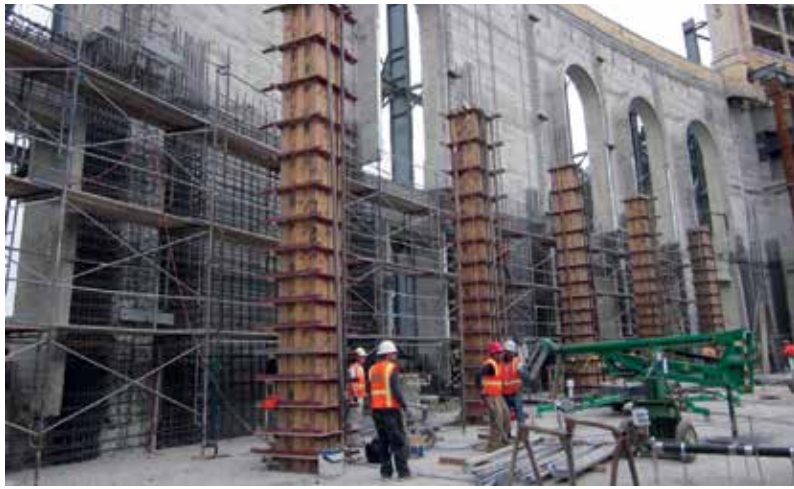
Fig. 5: Application of 40 ft (12.2 m) tall shotcrete layer 36 in. (914 mm) thick over the existing historic perimeter wall

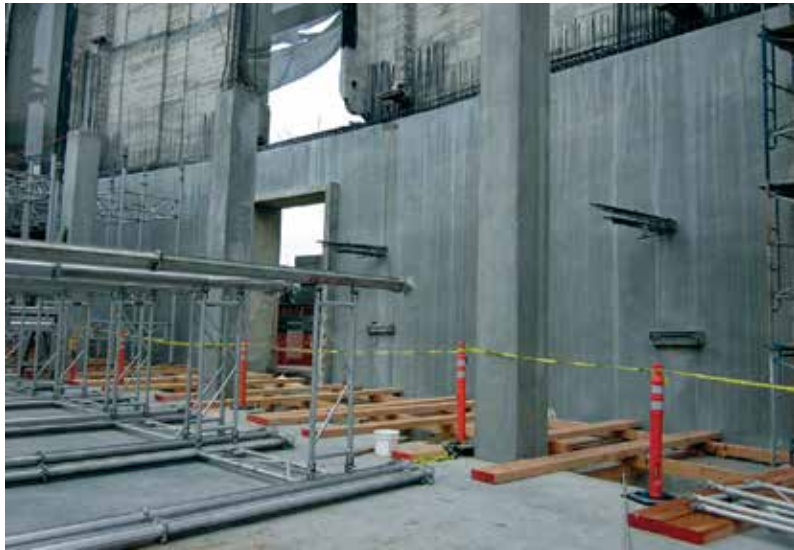
Fig. 6: Existing historic wall after shotcrete overlay application

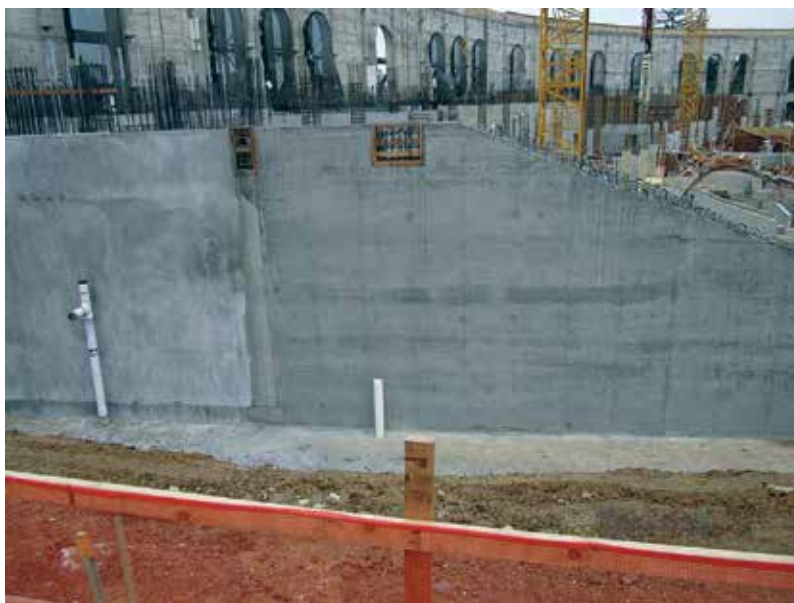
Fig. 7: Shotcrete shear wall after the forms were stripped. The right side of the wall is the stripped form side. The left side is the shotcrete steel trowel finish side

The walls were applied in one layer of scratch coat from the bottom to the top, and then the final finish coat from the top down was later applied (refer to Fig. 7). By taking this approach, JWG was able to ensure a uniform steel trowel finish. A unique experience at this project was that JWG found that the use of additional water-reducing admixture was actually detrimental to work production. As a result, JWG used a low dosage when applying a scratch finish so more concrete material could be stacked on the wall. The dosage was increased when applying the final coat finish, which accommodated extra time for the finishers to complete their work before the concrete set.
